service bulletin

No. 97-20

EFI and MPI Fuel Line Replacement

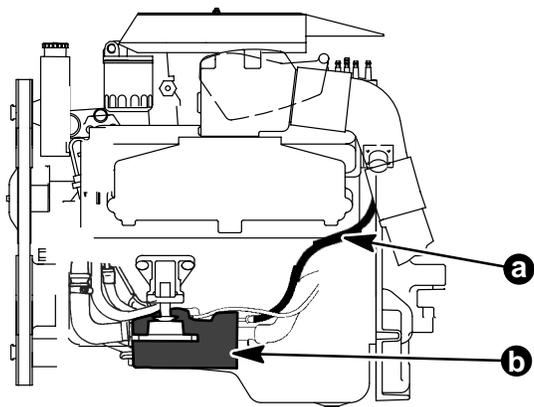
75704

Look at the fuel cooler to TBI fuel line. If it is braided, the fuel line IS GOOD and does not have to be replaced.

- a - Fuel Line to TBI
- b - Fuel Cooler.
- c - Braided Fuel Line.

Change incorrect fuel lines on any engine that you have in stock. If the boat has been sold, please contact your customer and perform this service on their engine(s).

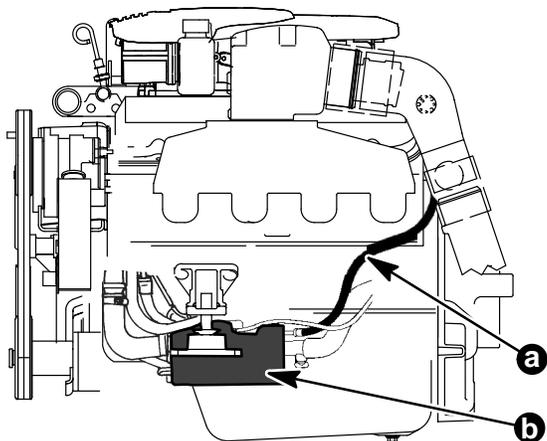
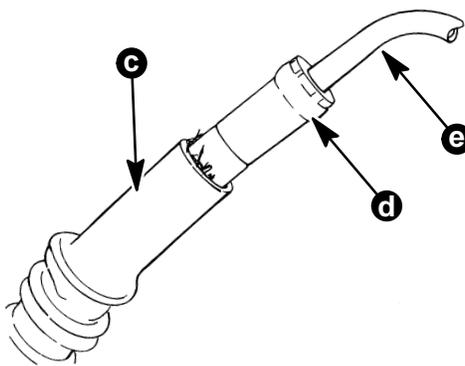
Look at the fuel cooler to fuel rail line. If the fuel line has a 'fire sleeve' AND the metal hose coupler is brass, the fuel line IS GOOD and does not have to be replaced.

- a - Fuel Line to Fuel Rail.
- b - Fuel Cooler.
- c - 'Fire Sleeve' Pulled Back.
- d - Brass Hose Coupler.
- e - Stainless Steel.

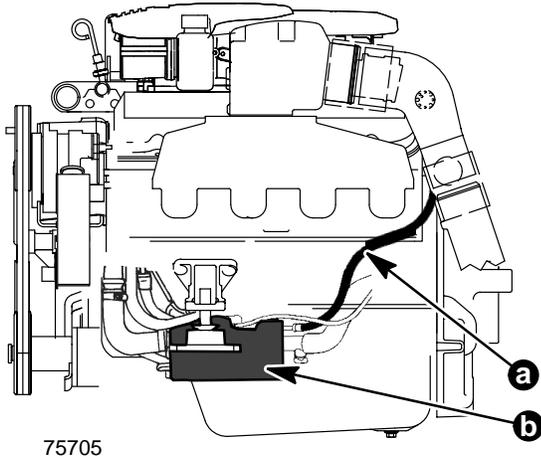
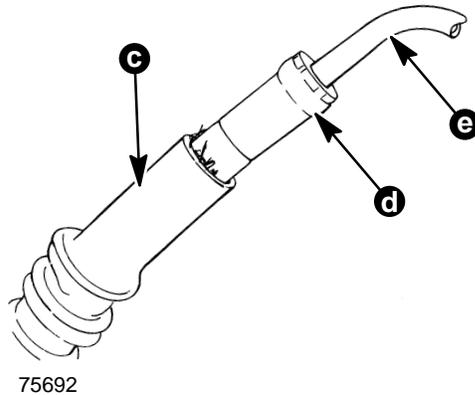
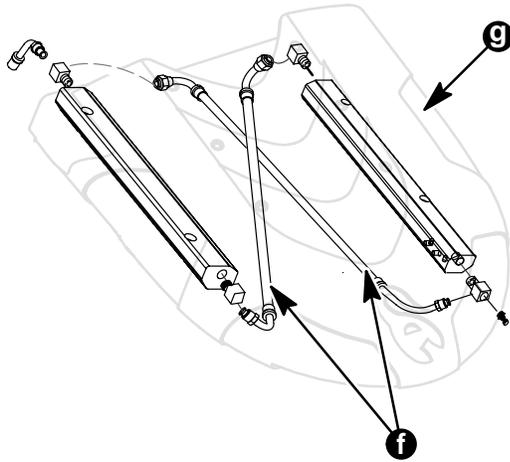
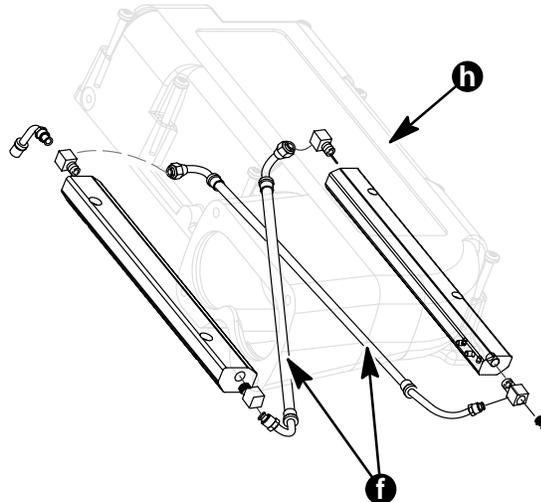
- a. Look at the fuel line to fuel rail line. If the fuel line has a 'fire sleeve' AND the metal hose coupler is brass, the fuel line IS GOOD and does not have to be replaced.
- b. Also look at the 2 rail to rail fuel lines. If the fuel lines have a 'fire sleeve' AND the metal hose couplers are brass, the fuel lines ARE GOOD and do not have to be replaced.

- a - Fuel Line to Fuel Rail.
- b - Fuel Cooler.
- c - 'Fire Sleeve' Pulled Back.
- d - Brass Hose Coupler.
- e - Stainless Steel.
- f - Rail to Rail Fuel Lines.
- g - Scorpion Intake Plenum.
- h - 1997 350 Mag MPI Plenum. Not On 1998 350 Mag MPI Engines.
